**BULLETIN OF THE
SERVICE CITIZENS OF DELAWARE**

**GENERAL REPORT ON
SCHOOL BUILDINGS AND GROUNDS
OF DELAWARE**

OCTOBER 15, 1919

GEORGE D. STRAYER

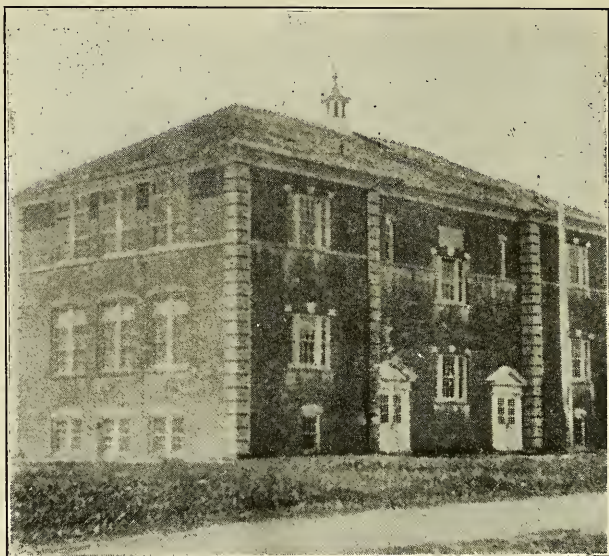
GREENWOOD SCHOOL

The Greenwood building is a six-room, two-story brick structure, built in 1915. It is rectangular in type, with a shingle roof and concrete foundation. In external appearance it is an attractive building, but the grounds have not been improved and nothing has been done in the way of planting shade trees or shrubbery which would improve the environment. The site is unusually large for school buildings in Delaware, but still under standard size. It is, however,

being put to use, a grandstand having been erected and a baseball field laid out. It has many possibilities of further development. If expert advice had been sought in checking up the educational requirements upon the building the community of Greenwood would have today a much more efficient school plant than it now has. There is also striking evidence of poor economy both in the quality of workmanship and the material which has been placed in this building. A

direct system of heating has been installed, with the boiler located in the basement. The radiation is apparently adequate, but no provision for ventilation has been made.

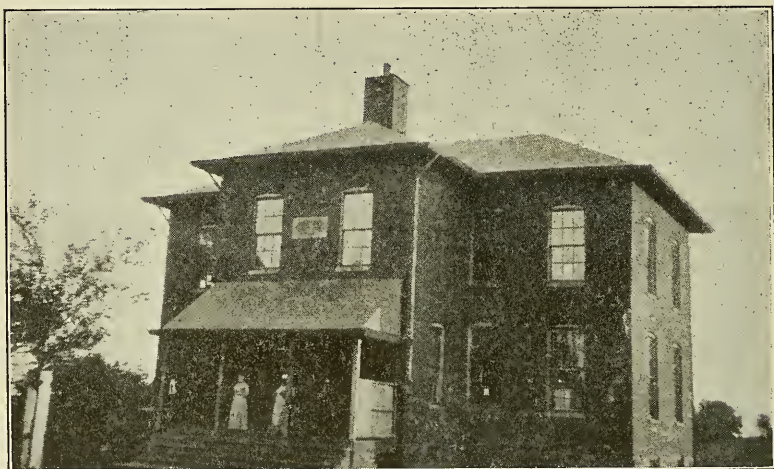
NEWPORT SCHOOL

Class rooms are slightly under size and do not conform to standard, but for comparatively small classes will serve adequately. The glass area is up to standard, but the windows are distributed so as to supply light from three sides.

The auditorium, which has the possibilities of use as a community room, is made ineffective by the placement of permanent seats facing each other in the two rooms, which can be thrown

together by a movable partition. In order to take full advantage of the opportunities offered by this room, movable type of seats should be employed. Two playrooms in the basement of the building were being finished at the time of the survey. These rooms, though poorly lighted, will make a distinct contribution to the usefulness of the building.

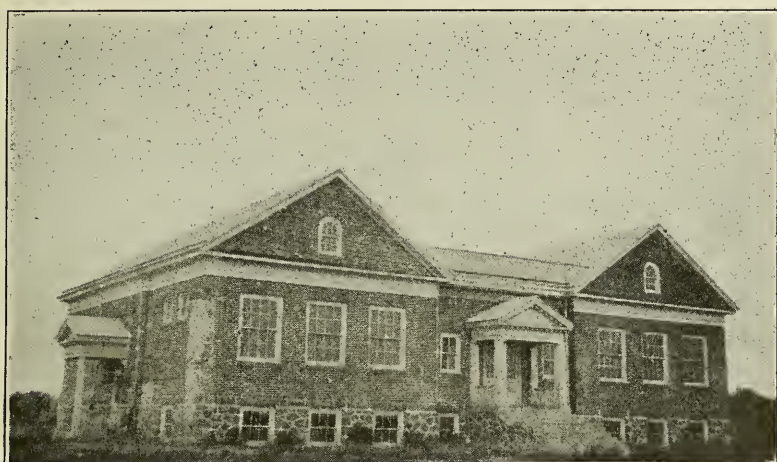
OAK GROVE SCHOOL

The building, being new, is in excellent condition and evidences good material and good workmanship throughout its entire construction.

tion. It is heated by direct steam, but no provision has been made for forced ventilation. Class rooms and corridors are lighted by electricity, but the number and arrangement of outlets are not sufficient to entirely meet the needs of the building for evening use for school purposes. Adequate provision is made for drinking facilities, but the number of wash basins is below standard and no provision is made for bathing. Indoor toilets, adequate in number, well fitted up, and especially clean and sanitary, were found in this building. In this respect the building stands out in marked contrast to almost every other school building in the State.

oped. The plot is new, and as yet no extensive effort has been made to beautify or improve the grounds, but the situation evidences on the part of the community a disposition to have a very good school and surroundings; therefore, will undoubtedly continue to improve. Trees should be planted, gardens and lawn plots developed, and walks put in where needed. The present board walks are not in keeping with the buildings and are evidently not intended to be permanent in character.

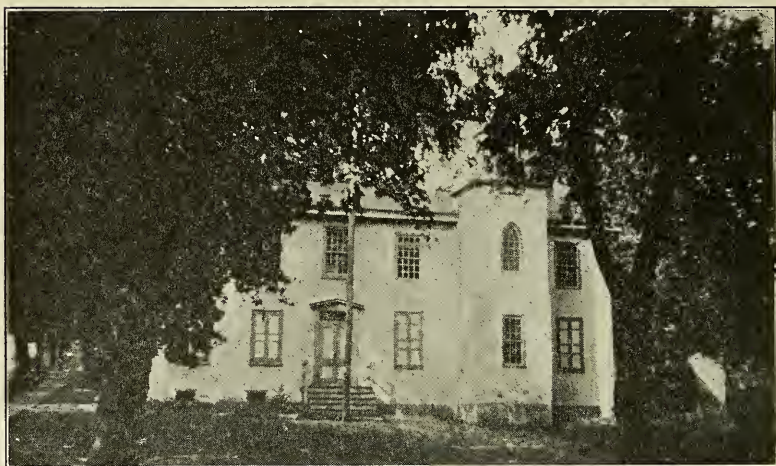
ODESSA SCHOOL

needs for which it was built, it has outlived its usefulness as a school building and should be closed for such purposes.

The grounds upon which the building is located are made

unusually beautiful by the large number of old maple trees that cover it. It seems a fitting suggestion that this grove be retained as a public park for the village and that a new and adequate school site be selected.

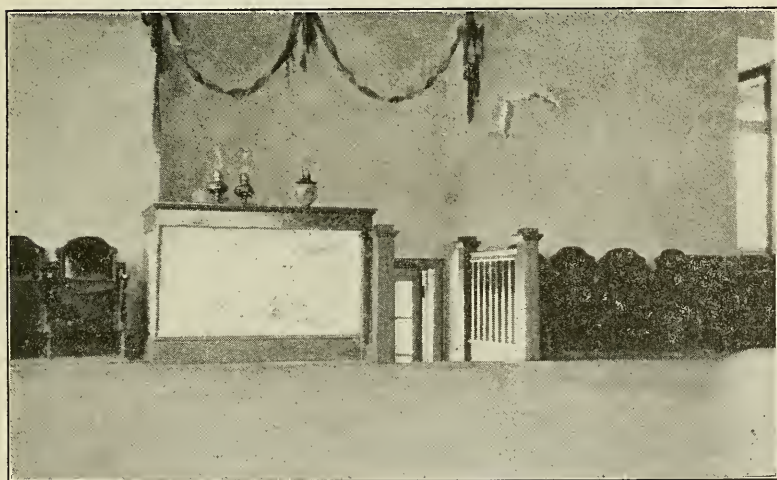
Special rooms. Full credit was given for the auditorium, as it represented an earnest effort on the part of the community to provide a good school and community assembly. The one most serious objection to this room is the absolute inadequacy of the exit. The room will seat comfortably 250 people, and the only means of entrance or exit is by means of a stairway, 39 inches wide, located in the center of one side of the room. A fire or panic in the auditorium would result in the death of a great many people. The auditorium should not be used for any purpose until adequate fire escapes are placed on the building, the same having doors cut to the floor level and provided with panic bolts.

THE ONLY EXIT FROM THE AUDITORIUM OF THE
TOWNSEND SCHOOL

This room, with a seating capacity of 250, is located on the second floor. The exit shown in the picture is 39 inches wide, and through it lies the only means of escape. It was stated locally that it takes from twenty to thirty minutes to empty a "packed hall."

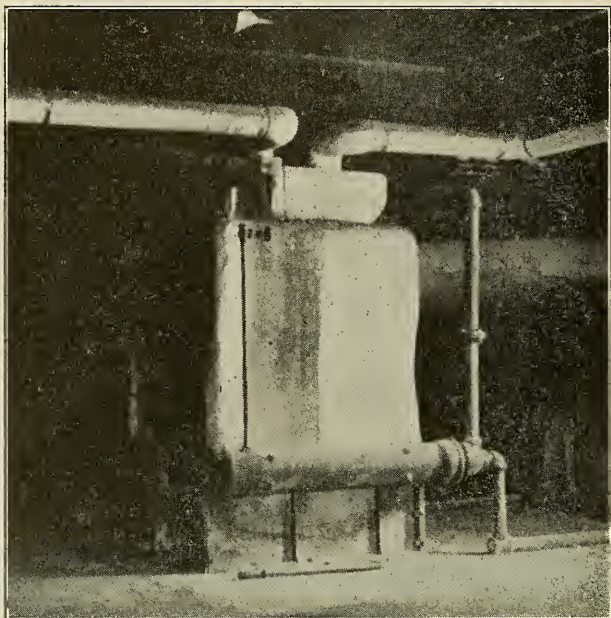
THE HEATING PLANT, SHOWING THE EXPOSED WOODEN
JOISTS DIRECTLY UNDER THE STAIRWAY

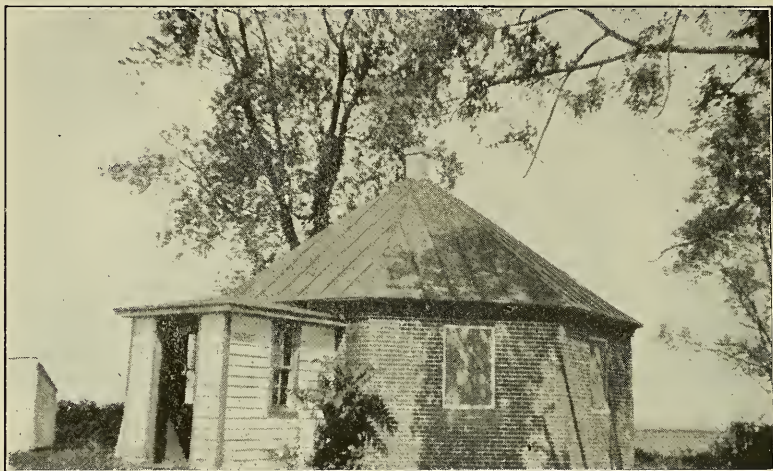
EIGHT SQUARE SCHOOL

As a monument to a bygone age in education, "Eight Square" is a most interesting type of building. At a time when it was considered essential to one's educational development that he be within easy reach of the master's rod, an octagonal room may have had peculiar advantages, but in the present era, when the angle at which the light falls upon the pupil is regarded as more important than the angle at which the rod falls, Eight Square is out of place as a school building.

The scores indicated above point to a very certain condemnation of the building on every major item of consideration. Reference to the detail score, will show that the environment of the build-

ing is the only commendable feature which it possesses. Because of its lighting features alone, if for no other, it should be closed for school purposes.

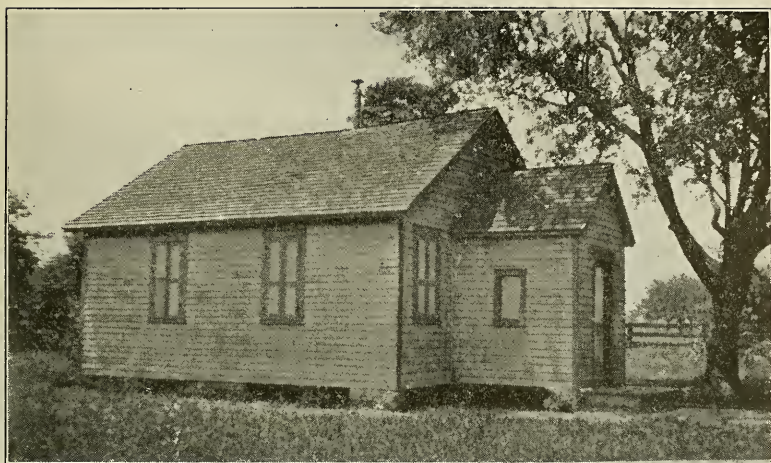
JAMISON'S CORNER SCHOOL

The slightly higher score of this building is due not so much to the building itself as to the fact that good roads make it accessible and that there is some evidence of effort to improve the environ-

ment. A painted fence in good condition adds much to the general appearance. The building is so small and so nearly square that the problem of heating becomes very serious. As the seats are located and the stove placed, children are compelled to sit within 16 inches of the fire bowl of the coal stove that occupies the center of the room. Twelve new adjustable single seats and an excellent teacher's desk adds to the appearance of the equipment, but the fact that the room is lighted from three sides and that it does not qualify in any major items of consideration condemns its further use.

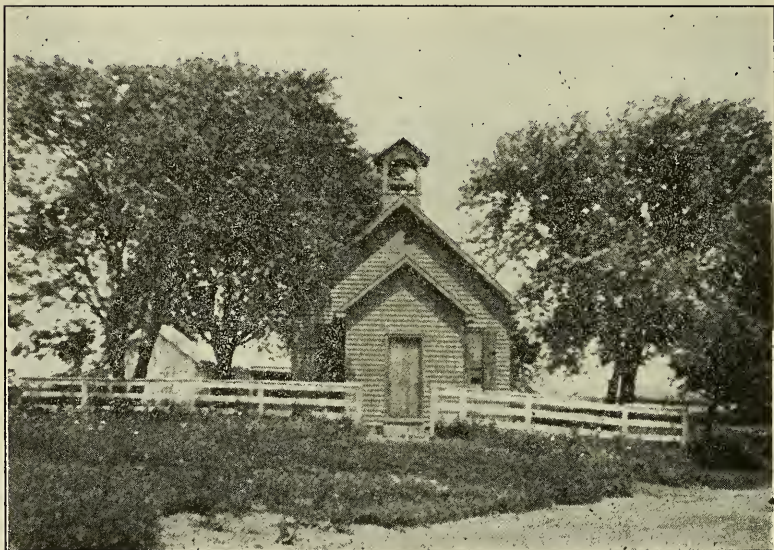
HICKORY GROVE SCHOOL

of flowers, grass and trees. A tall, inspiring flagpole carries an enormous flag—the flag that is supposed to float over a land in which equality of opportunity is the right of all.

Almost in the shadow of this flag stands the Hickory Grove School that scores, in point of adequacy, 328 points out of a possible 1000. No flag floats over it, nor has any provision been made that it might do so. A meager little site, the size of a town lot, offers little opportunity for the recreational needs of the children. The class room is lighted from three sides and heated by a stove placed in the center of the room

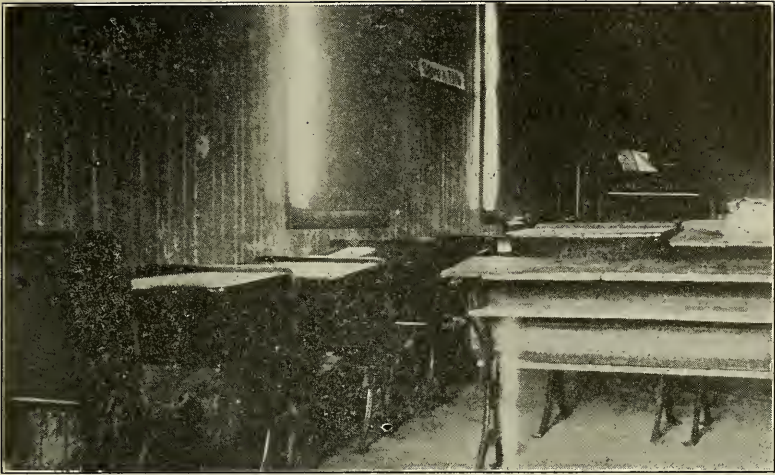
BLACKBIRD, DISTRICT NO. 69

Class room. Seatings, if the carved and mutilated double

benches can be rated as seatings, are provided for 45 children in a room 18x27. In order to get this number of seats in it has been necessary to place the seats squarely against the walls on both sides of the room. This arrangement precludes the possibility of side aisles or the use of the side walls for blackboard space. The accompanying picture shows the lighting conditions which the children so seated are compelled to suffer. The survey commission wishes to place special emphasis upon the recommendation that this building be closed.

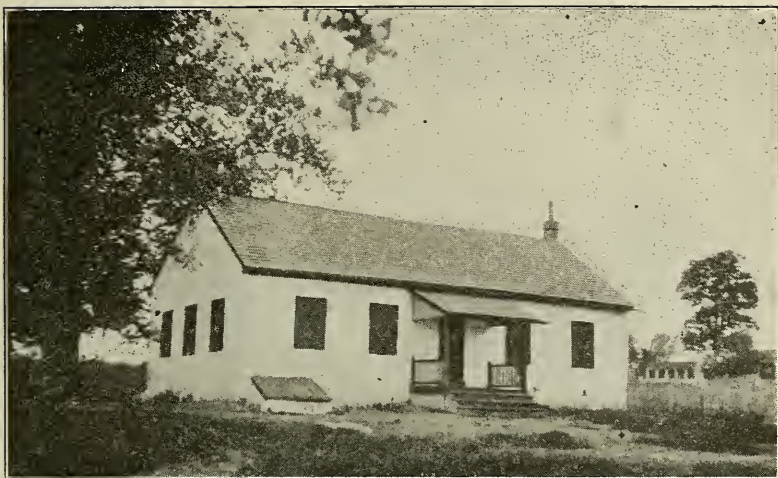
ROCKLAND, DISTRICT NO. 8

This building is a two-room, one-story, stone structure, erected in 1831. Considering its age, it is in a fair state of repair and evidences a very commendable spirit on the part of the community to make of it the best possible school accommodations. The building and grounds are neat, clean and, in so far as possible, attractive. The site, triangular in shape and ill-adapted to recreational needs, is nevertheless pleasing in general effect, due to the large shade trees that surround the building.

In the light of the new educational program in the State of

Delaware, this building should be abandoned for school purposes, and the children heretofore attending this school should be transported to the proposed large consolidation near Tallyville.

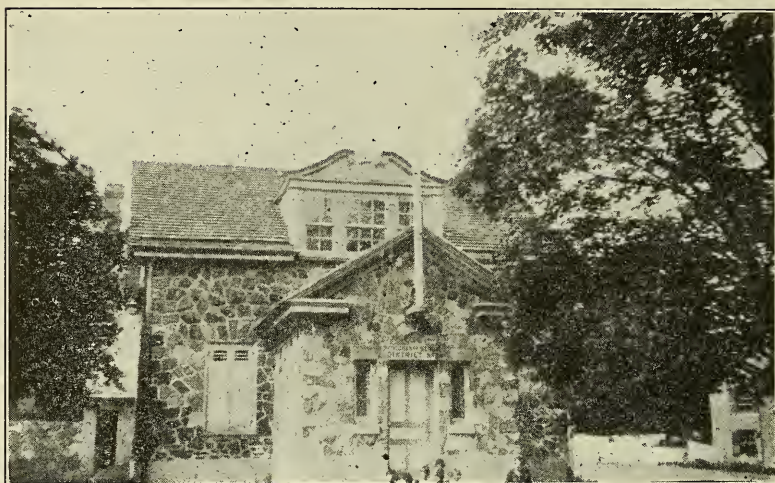
MONTCHANIN, DISTRICT NO. 24

The heating system of the building is of good type. The rooms are clean, well-kept, and drinking water is supplied from a well located on the school grounds. The toilets, though of the outside type, are in better condition and generally more acceptable than those commonly found in the State of Delaware.

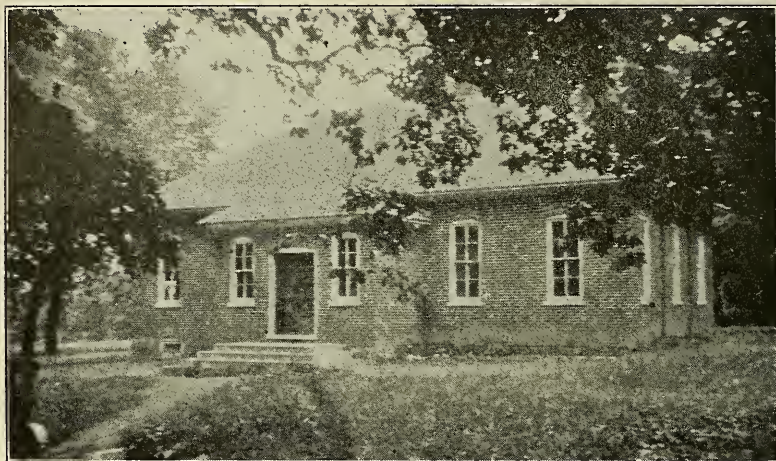
BRANDYWINE SPRINGS SCHOOL

This is a new one-story, two-room, brick building, located on a somewhat larger triangular site than is commonly allotted to rural school buildings in the State of Delaware. The site is joined on one side and in the rear by dense woods and has not been improved or developed for recreational purposes in any way. The building is, however, in good condition and possesses the possibilities of being

A direct steam-heating system has already been installed in this building, and with the addition of adequate artificial light and a water supply system, together with the proposed inside toilets, the score on service systems would approach a satisfactory minimum.

The class rooms, although better in many respects than those found in the older buildings, still do not recognize the importance of the best light—the light now being admitted from three sides. This error should be corrected if the building is to be continued in service.

made into an excellent two-teacher, six-year school. In order for this building to meet the standards required for such a school, and in order for its score to be made acceptable, it will be necessary for the present site to be materially extended, developed and improved. Playground and recreational apparatus should be installed; the outdoor toilets should be done away with, and space be provided inside for water-flush or chemical toilets.

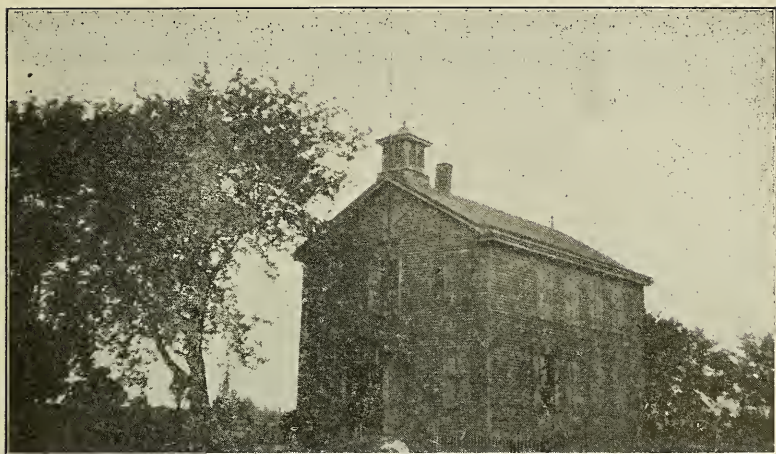
ST. GEORGE'S, DISTRICT NO. 53

The St. George's School is a very old, two-room, two-story, frame structure, with tin roof and brick foundation, located on a site approximately 180x120 feet. The site is too small to meet the needs of this rather large group of children, and because of adjoining village residences; the site is difficult of adequate expansion.

It is not consistent with the modern educational policy that the children of this community be housed continuously in a building

which provides nothing more than is possible in this structure. It should, therefore, be disposed of and a plant adequate to the needs of the community and large enough to justify a complete educational-recreational program supplied.

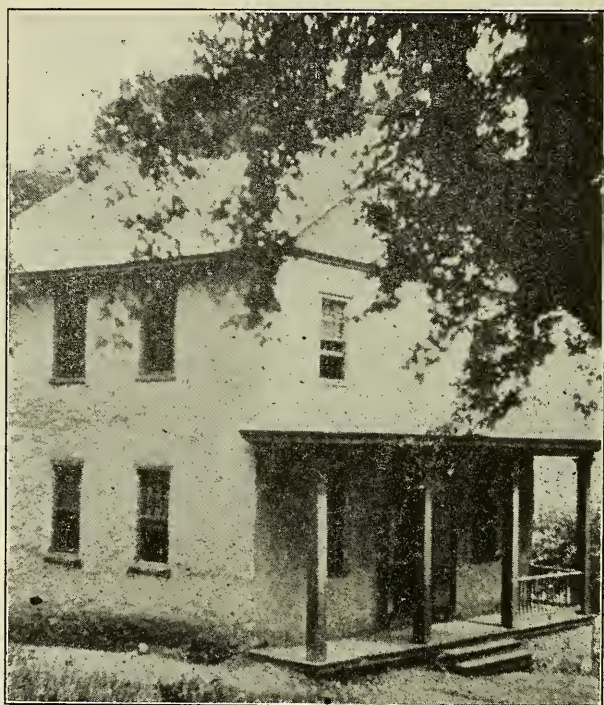
YORKLYN, NO. 91

The Yorklyn School is housed in a very old two-room, two-story brick and plaster structure located on the side of a steep hill and surrounded by many large, beautiful old trees. More by way of commendation can be said of the trees than of any other part of the school plant. The site, because of its location on the side of a hill, is impossible of use in the development of a recreational and educational program. The building was constructed long before any notion of educational standards in building construction had been developed. In the light of this fact, the building is entirely inadequate for modern needs, and as a school building it should be closed. The building does, however, have to its credit a system of direct heating and an inside water supply system, with drinking fountain, has been installed. The toilets are located on the high ground above the building, but some measure of protection has been taken by the construction of fairly adequate toilet vaults. The Yorklyn district cannot afford, from an educational point of view, not to seriously consider the consolidation of their district with that of Hockessin and two or possibly three other neighboring districts, for the purpose of constructing a large educational center at some point conveniently located with respect to the districts concerned.

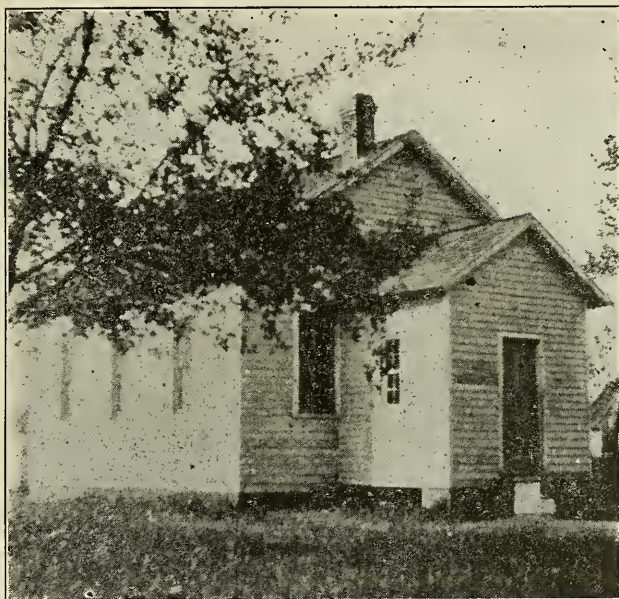
BLACKISTONS NO. I

This school building is a one-story frame structure that was built in 1881. It may have answered the demands of education at that time, but recent years have seen rapid progress in the requirements upon rural school buildings. It is, therefore, imperative that if the district of Blackistons is to keep pace with educational progress it is necessary for it to abandon this building and construct a new one. The service systems and equipment are in keeping with the rest of the building and should be cast aside at the same time as the rest of the building.

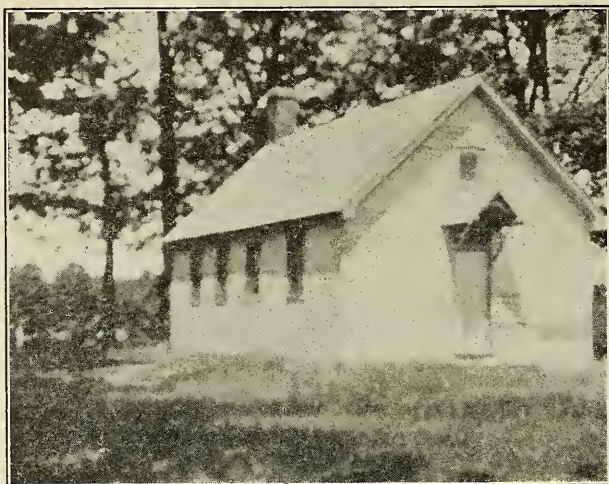
FAIR VIEW NO. 15

This building is a one-room, rectangular frame structure, located on a site 100x150 feet in a beautiful grove of oak trees, surrounded by open fields. The site, except for size, is the most commendable feature of the plant. Little attention has been given to the comforts and the physical needs of the children, and the class room is extremely poor. As typical evidence of this neglect it was noted by the Commission that the only blackboard area in the class room was placed in the rear of the room. Similar lack of foresight and knowledge of educational needs is evidenced throughout the plant. Should this location be agreed upon as the logical one for a school building, the present site should be extended to include a number of acres of the adjoining fields and the grove preserved as a school park and a community ground.

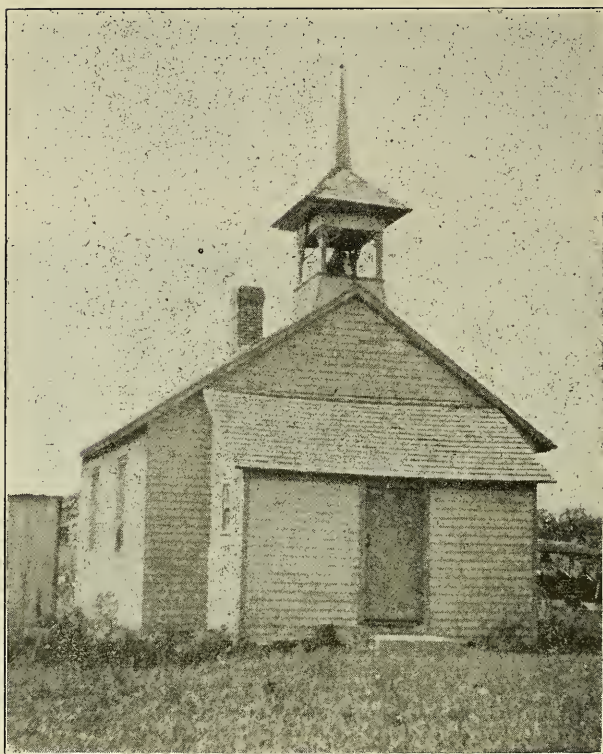
WESTVILLE NO. 69

The Westville school is a little one-room, frame building, 18x18, located on a rectangular site 100x150 feet. The building, which is not old, is in a fair state of repair, and in so far as possible, an effort has been made to adapt it to, what in the past, has been

regarded as adequate school needs. The very size, however, of the building condemns it as a school building, and as such it should be abandoned at once. The light area of the class room is low and poorly placed, there being but four windows, two on either side of the room.

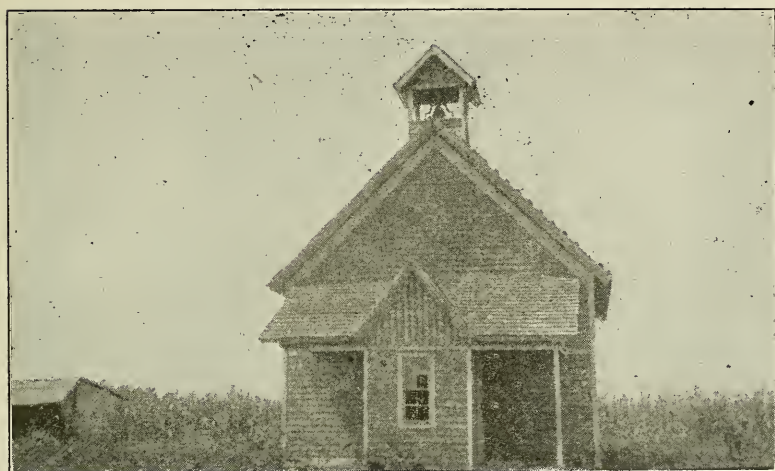
HOLLANDSVILLE NO. 87

The Hollandsville school is of the typical, rectangular, frame building type. It has a vestibule and protected entrance. The building is old and in very bad physical condition throughout. The entire situation at this building, from site to special rooms, is such

as to justify the urgent recommendation that the citizens of this community take immediate steps to provide an adequate school plant for the education of their children. No single feature of the building approaches a satisfactory standard.

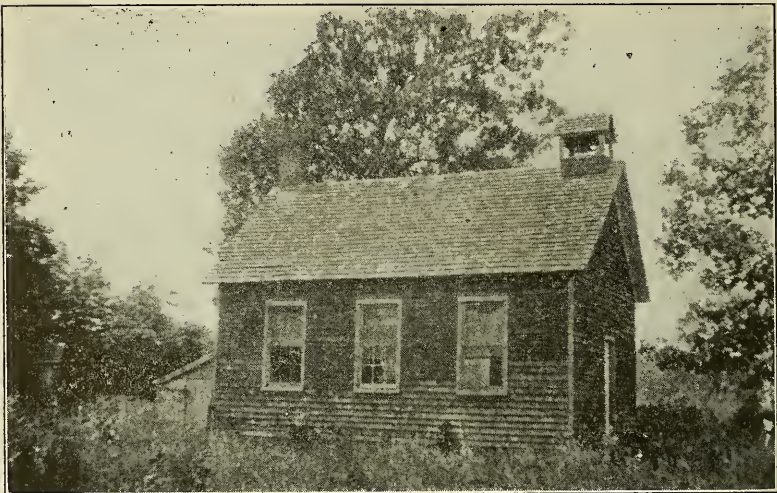
POTASH NO. 100

This building would delight the soul of the spread-eagle senator who would rise to dizzy heights of oratory in reciting to his constituents the blessings of the "Little, old, red schoolhouse in the lane." It answers the description of that traditional institution in

every detail except that a modern heater has been installed. It is located in a dense woods and all of the little tract of land which at one time was cleared for the school building has grown up in dense briar and small underbrush. Aside from exciting the type of oratory above mentioned the schoolhouse of this type does not serve adequately any of the purposes for which modern school buildings are erected. It should be abandoned at once and the children transported to more suitable quarters.

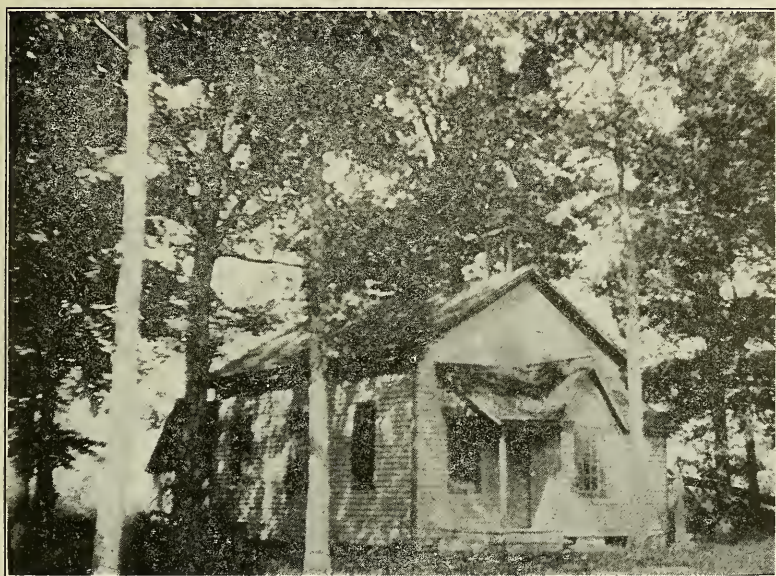
FOREST LANE NO. 104

The only commendable feature of this building is the beautiful grove of trees in which the building stands. This feature would be extremely desirable were the site extended to include the cleared space upon which recreational activities of the school children might be had. In the present situation, however, there is little room for games of any sort. The building is heated by a box wood stove, and all of the equipment and facilities in and about the building evidence the most abject poverty conceivable. In the opinion of the Survey Commission there is no justification in compelling children, under penalty of the law, to attend a school building which provides nothing more than is found in this building. It should be abandoned for school purposes.

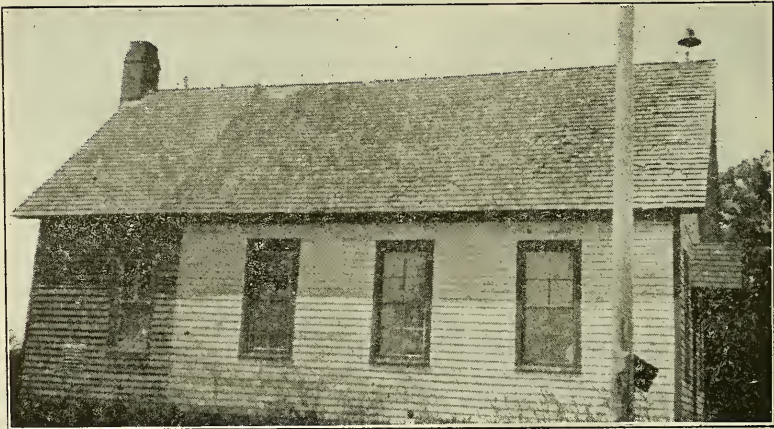
MARYDEL NO. 115

The Marydel school is a rectangular, one-room, frame building, 18x33, located on a site 60x100. The site is located on the top of a knoll which slopes off abruptly into marshy ground in three directions, thus making it impossible of extension or adaptation to school needs. The building is very old and in poor state of repair. The class room is slightly better than that in other buildings of its general type, but scores only 105 out of 225 points. Building and site should be abandoned for school purposes.

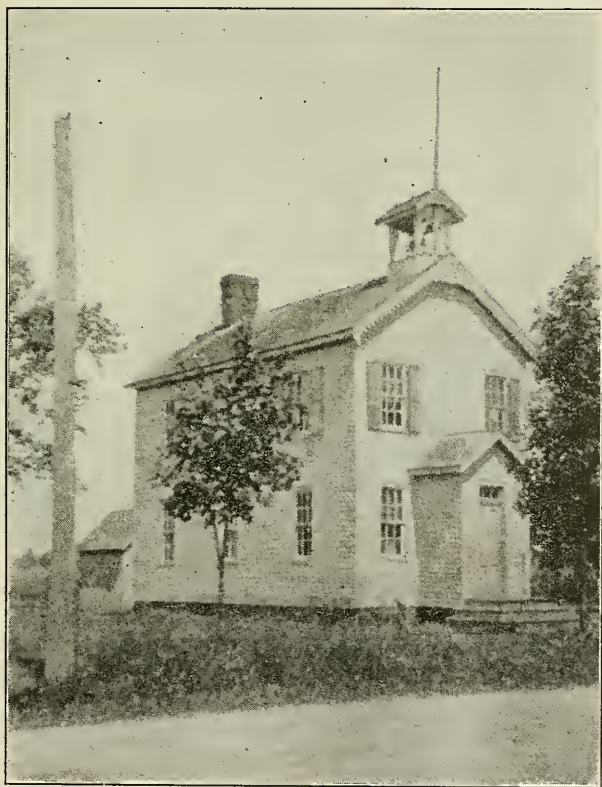
HARTLY SCHOOL

The Hartly School is housed in a very old two-story, two-room, frame building, in poor condition. The building is located on a very undesirable, unattractive site. The improved type of heater, thirty-eight new single seats and the good pictures which have been secured for the building represent its only commendable features. The number of children in attendance at this school would seem to justify the recommendation that a more adequate provision be made for a modern educational program.

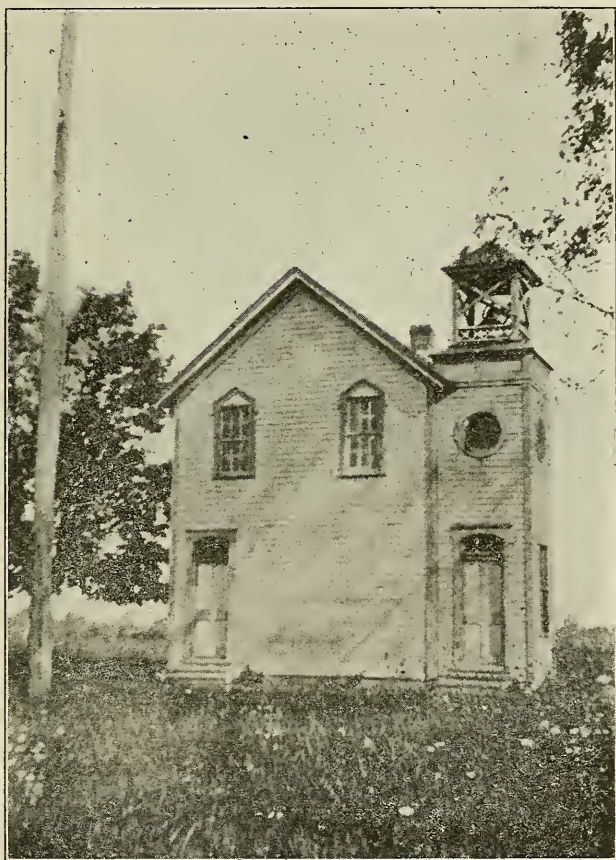
CANTERBURY SCHOOL

This two-story, two-room structure is located on an open rectangular lot which can be used for play purposes. The interior of the building would be a disgrace to any community. Plaster has been broken from the walls in many places; blackboards have been

torn down; furniture roughly treated, and the roof has leaked in places. Apparently no respect is paid to public school buildings by

the school children of this community, and probably this building with its equipment and cheap construction is entitled to little respect. The building has no attractive feature about it.

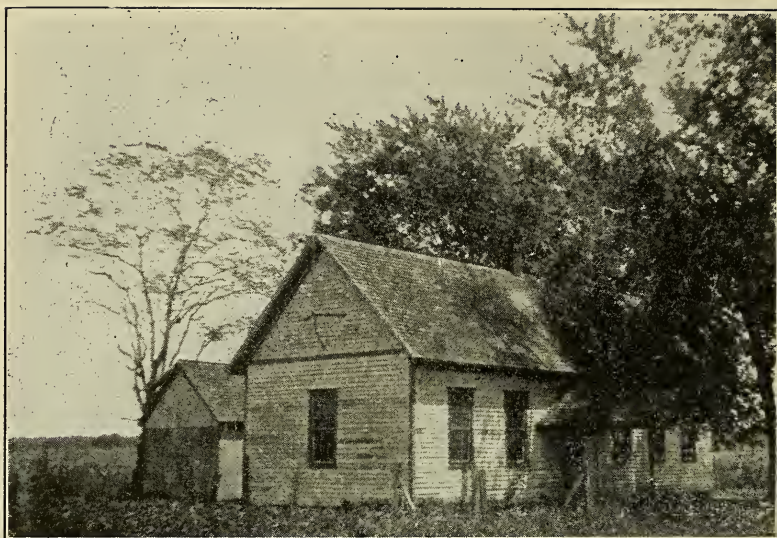
BETHESDA NO. 46

This is a two-room, one-story, frame building, located on a triangular site, the base of which is 100 feet, and the length of which is approximately 200 feet. The building is very old and poorly preserved. It offers the absolutely minimum of room space, and the service systems are of the lowest type which will permit of the assembling of children in groups. The class rooms are inadequately equipped, and the lighting arrangements are especially bad, one room being lighted from three sides. The fuel room, which from an educational point of view is perhaps the least essential, is the best feature of the building.

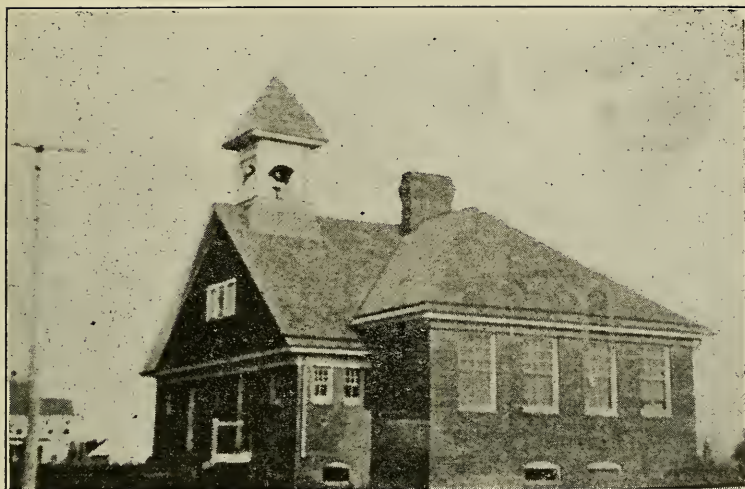
VIOLA NO. 112

actual needs and is undeveloped for recreational purposes. The building is cheaply constructed and certain very fundamental errors are outstanding. The foundation walls are but eight inches thick, and standing as they do in soil that is partially quicksand the building has settled out of line and considerable damage has already been done to the walls and building.

The building is provided with inside chemical toilets, which are in fair condition and apparently sanitary. It is to be noted, however, that but one toilet is provided for each sex. This, for a school of two large rooms is not sufficient to meet the needs of the pupils. The only way in which this building can be made to approach acceptable standards is by considerable alteration and extension of the building proper and development of the site upon which the building stands.

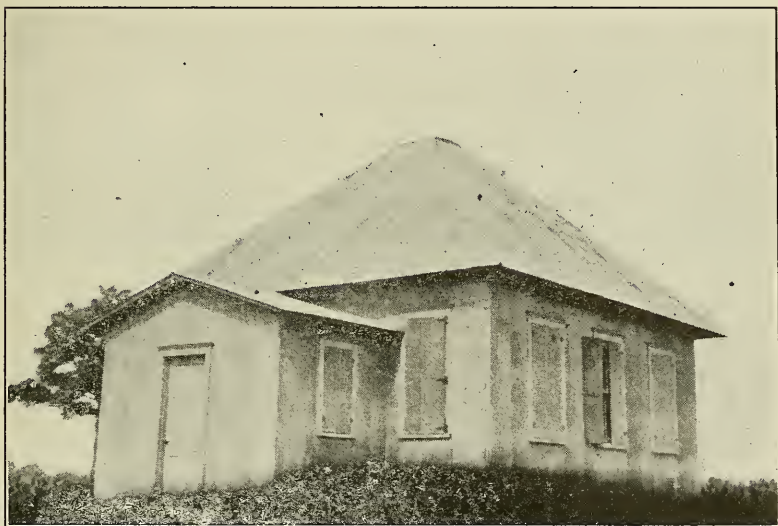
WHITES CHAPEL NO. 10

Whites Chapel is a new one-room structure, 20x22 in dimensions, with vestibule. It stands on a brick foundation. The site upon which the building is located is irregular in shape, approximately 100 feet in width and 300 feet in length. This building is a very unusual type of school building. It is made completely, walls and roof, out of corrugated, unpainted iron and resembles a garage rather than a place in which children are to receive their educational training. It does not speak well for the attitude of the community towards education or the welfare of their children. Apparently it is the cheapest type of construction which could be found. An improved type of heater is located in this building and water is supplied by a pump located in the vestibule. The class room, which seats 32 pupils, is entirely too small and of unapproved shape. The glass area is up to standard but distributed on three sides of the room. The vestibule provides space for cloak rooms, but as such is not acceptable.

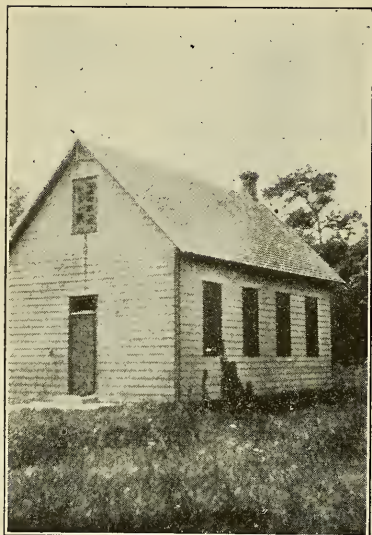
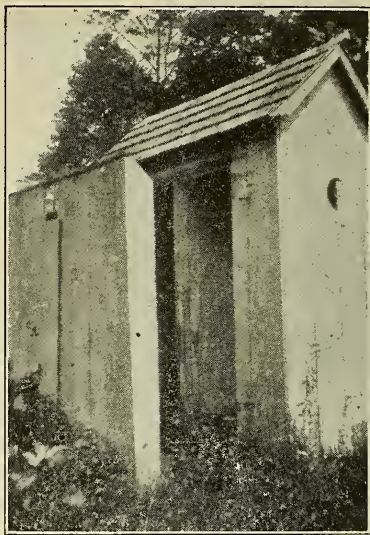
ELDORADO SCHOOL

This building, 18x28, situated on a site of indeterminate area, has concrete steps leading to its front door. The floor of this building is poor, the shades in bad condition but excellent book and sup-

ply closets are provided. Provisions for seating 40 children in double seats were found. The teacher's desk was of a fair type and slate blackboard is provided in sufficiency. No clock and no pictures were to be found. The building has a sufficient amount of window area, half of which, however, is in the wrong place. The only out-

house for this school is a combination of two compartments, separated by a wood partition, each one of which was apparently designed for the different sexes. That such a combination of outhouses is not a desirable method of raising the moral tone of children, nor of teaching them sex education was quite evident from the obscene drawings and foul language with which the interior of these outhouses was coated.

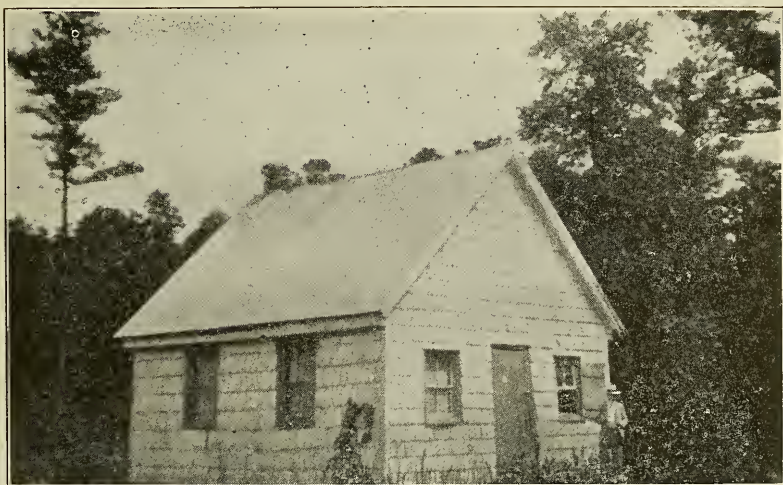
HILL'S NO. 21

The Hill's school is situated in a little clearing with forest to the right, rear and front, and an open field to the left. It is a whitewashed, shingle structure which is decaying rapidly. It has a roof of corrugated metal and a foundation of rotting wooden posts. The room is square, being approximately 18 feet each way, and is lighted by two windows on each of three sides. Even though lighted on three sides and even though the room is small, these six windows do not furnish more than half of the percentage between the window area and floor area that is considered to be the standard. A box wood stove, without jacket, is located toward the front center of the room. The seats are placed on stilts and occupy a large part of the class room. The floor is in fair condition, but only a distance

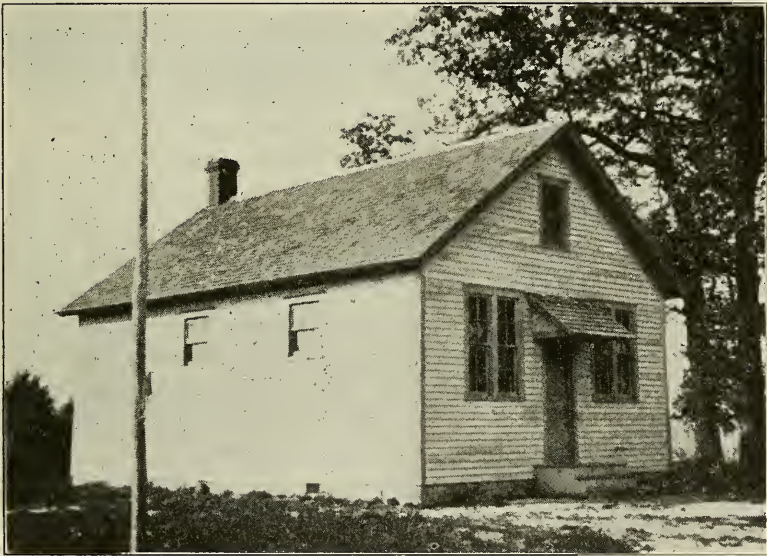
JOHNSON'S NO. 85

This school is a new one-room, frame building, 21x32, with concrete foundation and vestibule. It is located on a site approximately 100x150 feet, which is in good condition and well kept. The building is located on an excellent highway and is easily accessible. An excellent type of vestibule providing fairly satisfactory cloak rooms is included in the structure. The service systems, however, are much below the standard of the other features of the building. The class room is heated by a common stove. A pump is installed in the building. The outside toilets are in rather better condition and of better quality than found in other districts. The class room is the best feature of the entire situation. It is of good size and well shaped. Unfortunately the interior is finished in wood. This is not a standard type of finish. The blackboards are excellent and the glass area is adequate. The window area, in so far as the building plan is concerned, is not extremely bad. The windows have been banked on one side and three small windows have been placed high up on the opposite side of the room. These windows would not be seriously objectionable were it not for the fact that utter ignorance and stupidity have been shown in the arrangement of the seats. The seats and desks have been backed to the main source of light, thereby compelling the children to face all day long the two high windows in what has been made the front of the room. The seats should be turned in such a way as to place the main light source on the left of the pupils and the blackboards should be moved from the side of the room to the front. The seats and desks are of the single type of good quality and well selected as to size.

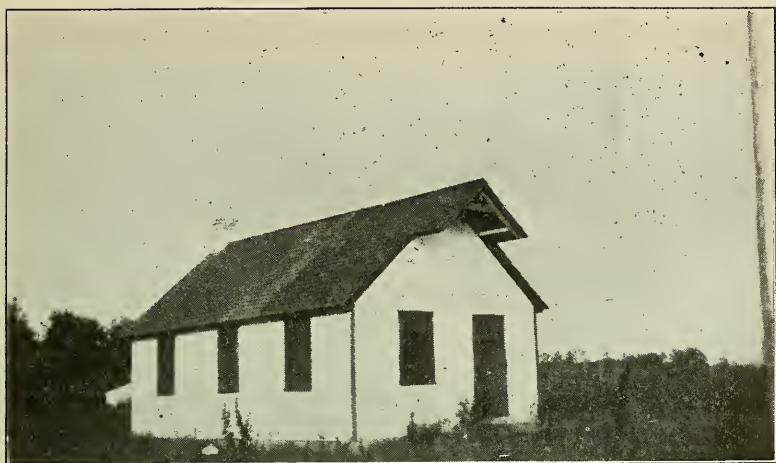
MUDDY NECK SCHOOL

This is a very old one-room, frame building, without vestibule or protected entrance. It is approximately 15x24 in dimensions, located on a triangular site, too small to allow for any recreational program. It is in very bad state of repair and presents every poor feature, from lack of service systems to lighting on three sides. The equipment is inadequate, the only feature thereof which is at all passable is the provision made by the installation of new double seats. Double seats, however, are not acceptable under modern educational standards. If consolidation cannot be effected for the children of this district a new one-teacher school, built on modern lines, should be provided.

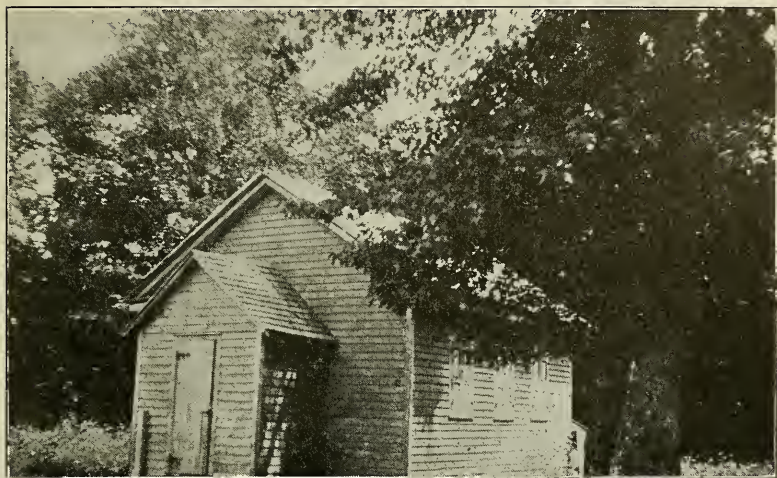
HOLLYVILLE SCHOOL

The building is 20 ft. long by 16 ft. wide and rests upon a brick foundation. It has a corrugated metal roof upon which the rain no doubt beats down to the disadvantage of school discipline. Two rows of single seats have been provided besides the double seats that are in use in this building. Apparently the only reason why single seats were provided was because the building was too small

for double seats, as the single seats have been placed against the wall even where the dead wall spaces are to be found between win-

dows. The building would make a fair sized woodshed but is altogether unsatisfactory as a schoolhouse. Its outhouses are in wretched condition and in close juxtaposition to each other and the school. One outhouse may be reached by wading through water at certain times of the year.

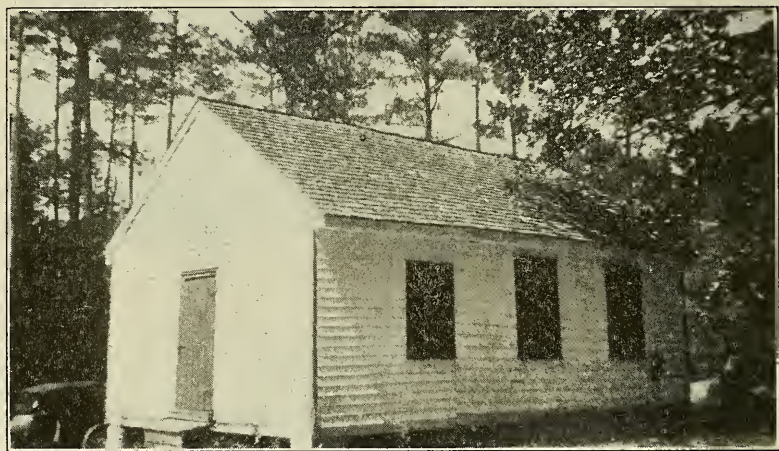
MCNEAL'S SCHOOL

The McNeal's school, locally and more appropriately known as "Hog Yard," is a one-room, frame building, approximately 16x22 ft. in dimensions, located in a small irregular, triangular clearing in an oak woods. Except for the narrow unimproved roadway running by the building the site is surrounded on all four sides by dense woods. The building is very old and in a very bad state of repair. The roof is moss grown and the open brick foundation offers little support to the building and no protection against cold winter storms to the floor of the class room. The site is too small and impossible

of extension or improvement to meet standard requirements. The interior of the building, except for the improved heater is of the type one might have expected to find in the pioneer schoolhouse. It is dark, dirty and untenable for human beings, unless, as is the case with school children, they are compelled by law to attend. The meager equipment is of the poorest type and much abused. Old double seats badly carved and mutilated are extremely unsatisfactory, and the teacher's desk is of the same general character. The glass area is low, and the windows are placed on three sides of the room. There is no justifiable excuse for the use of this building for school purposes, and in the light of modern civilization it should be condemned and closed. The pupils should either be provided with a modern one-teacher school or transported to a graded school at some point agreed upon with neighboring consolidating districts.

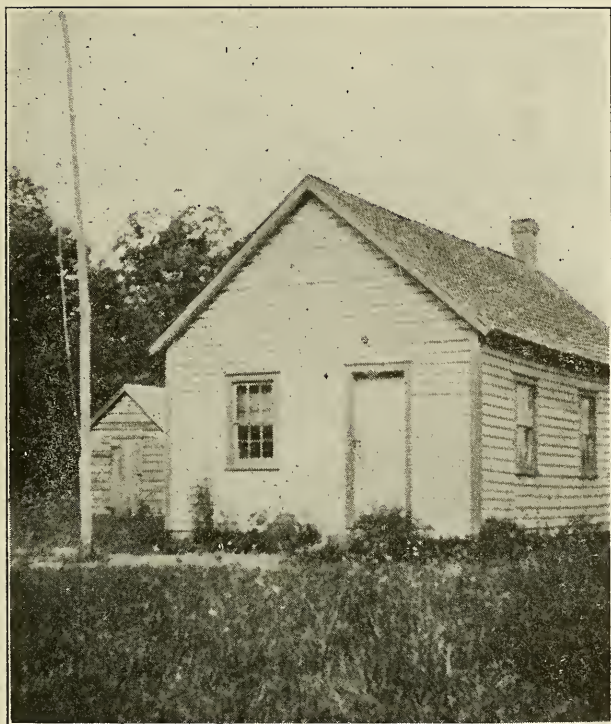
FOREST PARK NO. 179

This is a very old one-room frame structure without vestibule. 15x28 in dimensions, located on a lot approximately 30x100 ft. in a pine woods. The building is in a very bad condition and not suitable for improvement or worthy of consideration or enlargement. It is heated by a common wood stove which has a sheet metal jacket.

It is poorly kept and the outhouses are poor in quality and insani-
tary in condition. The class room is the traditional four wall affair,
with absolutely the minimum of equipment. The glass area is low
and distributed on the left, right and front of the room. The nine
square feet of blackboard space provided is to serve 30 pupils.
Such a situation can call for but one recommendation, that being the
speediest possible abandonment of the site and building for school
purposes.

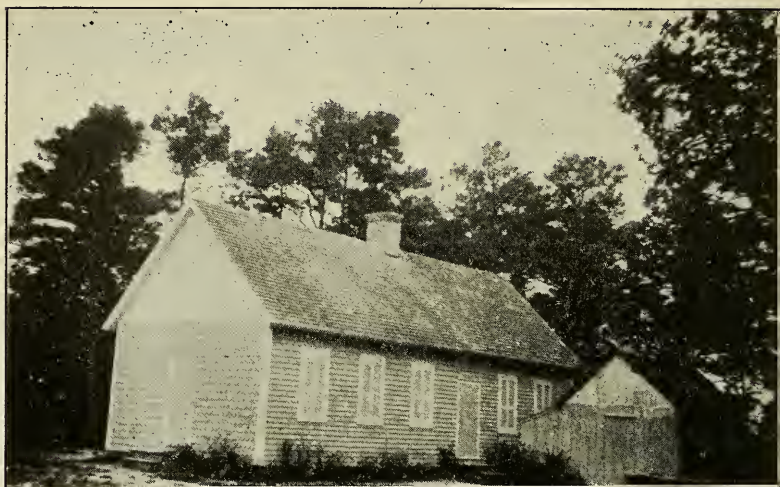
MIDWAY NO. 179

In this prosperous, attractive community is to be found a two-room, one-story, frame structure of a better type. In the first place the yard presents an appearance of orderliness which is quite unusual, although its standard is not high when compared with that of similar communities in other states. The cinder paths leading to the front porch, the outhouses and fuel house are not to be found in many schools in Sussex County. The brick foundation is in excellent condition. The large cement front porch and stairway is unusual and to be commended. The class rooms are lighted on three sides, although the six windows on the long axis would have sufficed. If the rooms had been built without the windows on the front and rear much inconvenience would have been obviated for both teachers and pupils. The following characteristics of the equipment of this building were unusual for Sussex County: A thermometer in the class room, a good enameled sink, a bubbler drinking fountain, a large clock in one room and a varnished bookcase with glass doors. An improved type of heater was found, although located within the class rooms.

It is unfortunate that it was deemed necessary to retain the old carved desks (which are of the double variety) in one of these rooms. A better type of teacher's desk and a rope for the flag pole should be provided. This building can be made a rather satisfac-

tory school structure by the addition of a play room, manual training and a domestic science. Consolidation with other districts in the neighborhood is possible.

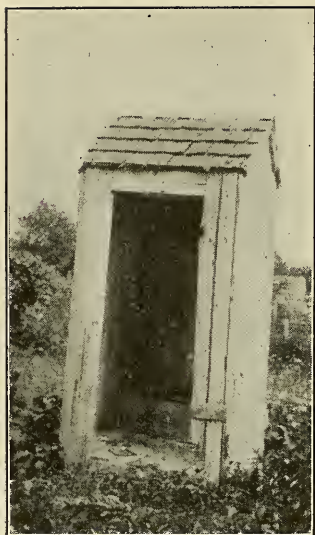
TYPICAL OUTHOUSE

Typical equipment and facilities provided the colored children of Delaware.

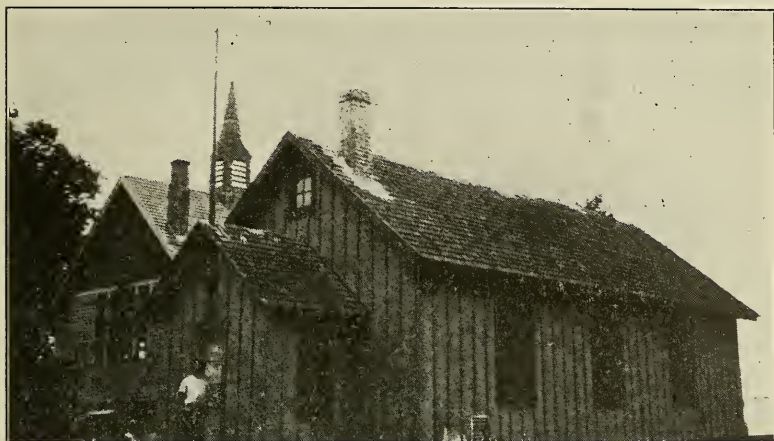
NEWPORT SCHOOL

The Newport School for colored children is a one-room, rectangular, frame structure, very old and in poor condition. The environment of this school is a church, graveyard and potato patch. The site is scarcely larger than the building itself, and the entire situation is most deplorable. It is unfit in every respect for the housing of children.
